**MERRIMACK RIVER BASIN
LACONIA, NEW HAMPSHIRE**

AVERY DAM

**PHASE I INSPECTION REPORT
NATIONAL DAM INSPECTION PROGRAM**

NOVEMBER 1978

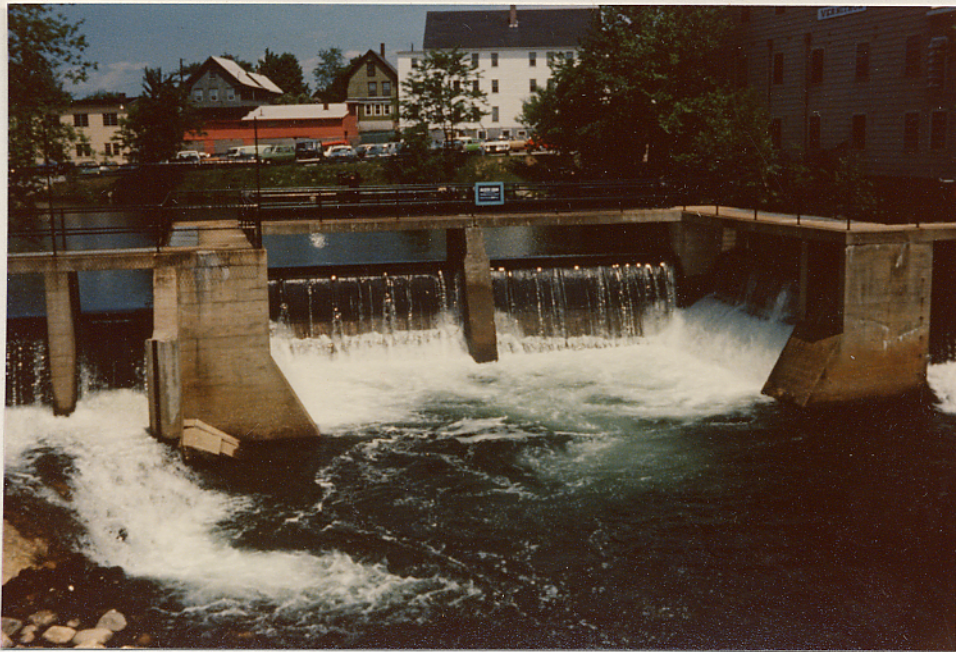
Overview from right side of
downstream foot bridge

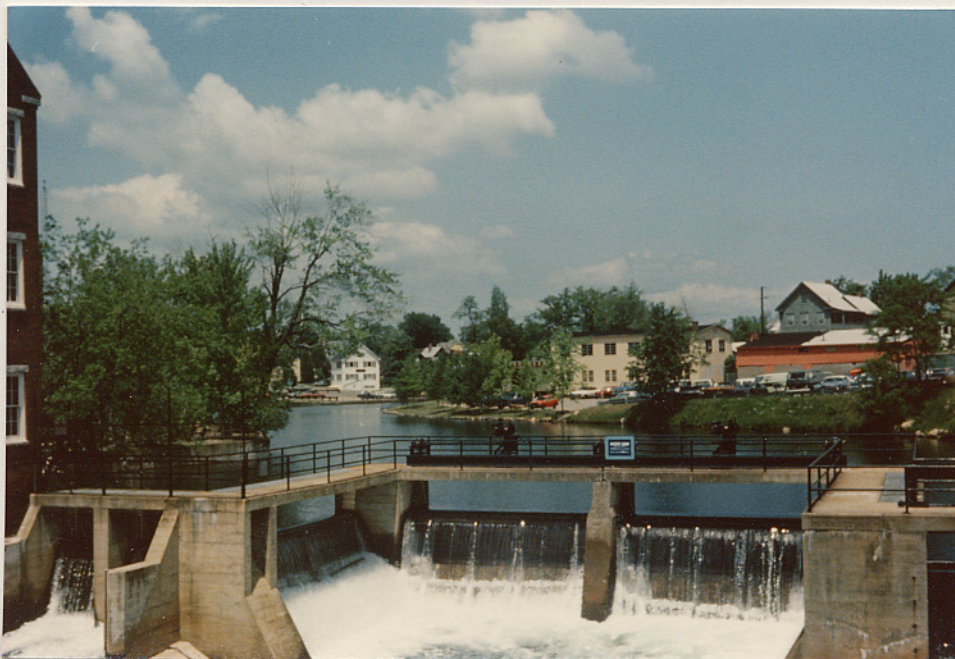
Overview from left side of
downstream foot bridge

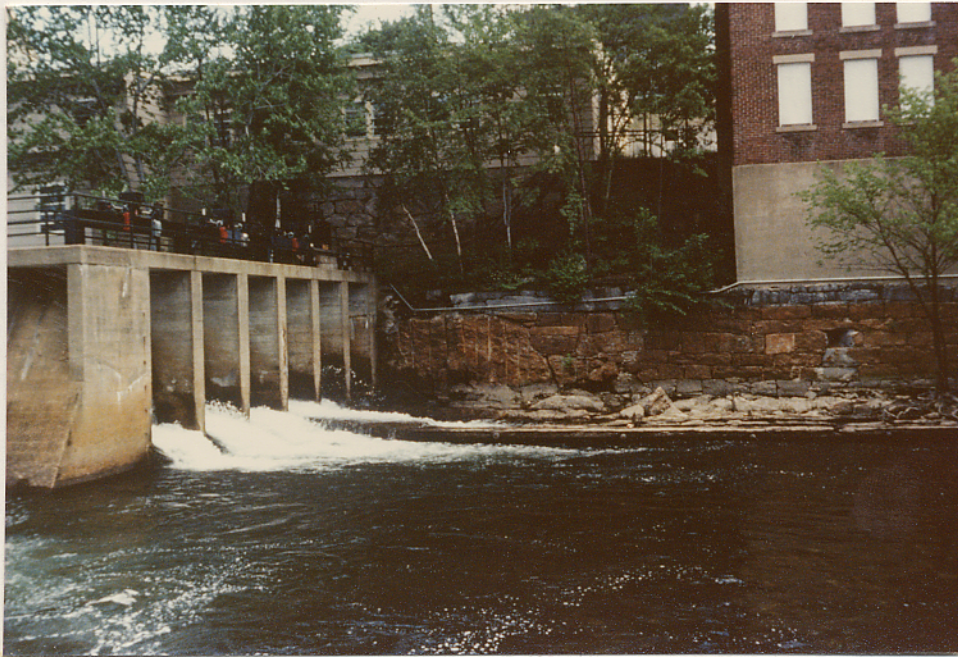
Overview of left side gate structure from
right side of downstream channel

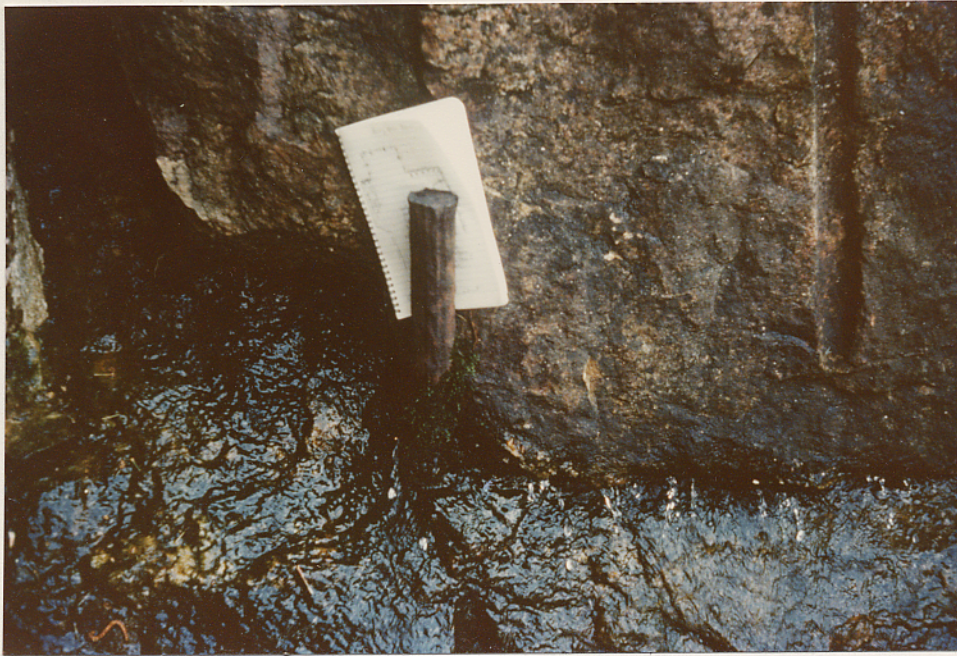
1. View of seepage near downstream side of left abutment

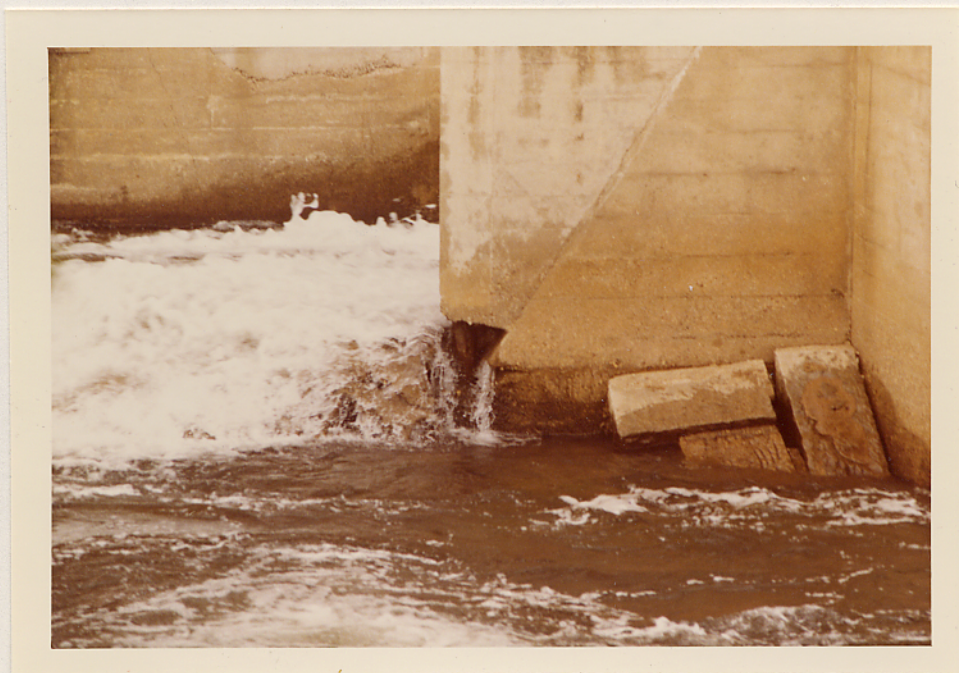
With the exception of the dividing pier between the sluice gate openings adjacent to the left abutment, the concrete is in good condition with minor exceptions. The base of the most westerly pier was subjected to erosion; however, proper maintenance has arrested further deterioration. The outlet sill of this structure has also suffered minor surface erosion exposing stone aggregate.

2. View of erosion under junction of spillway and right side gate structure

- (b) Repair the eroded slope revetment along the right training wall and monitor this area for future deterioration.
- (c) Repair all areas of cracked, spalled or eroded concrete, paying particular attention to the proper filling and sealing of joints and cracks.

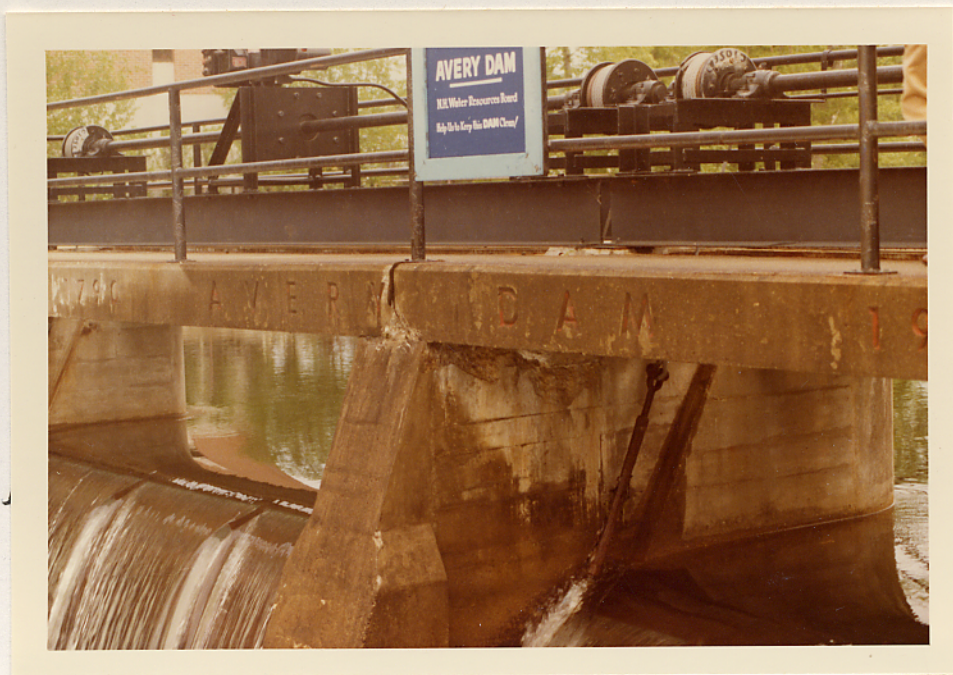
The concrete walkway is in fair condition. The walkway suffers from extensive cracking, spalling and efflorescence over the buttress dividing the hinged leaf gated spillways. Minor hairline cracking and associated efflorescence is also evident at the four reentrant corners of the walkway. The removable galvanized steel service gratings are in good condition.

3. View from downstream of open joint
in concrete service bridge

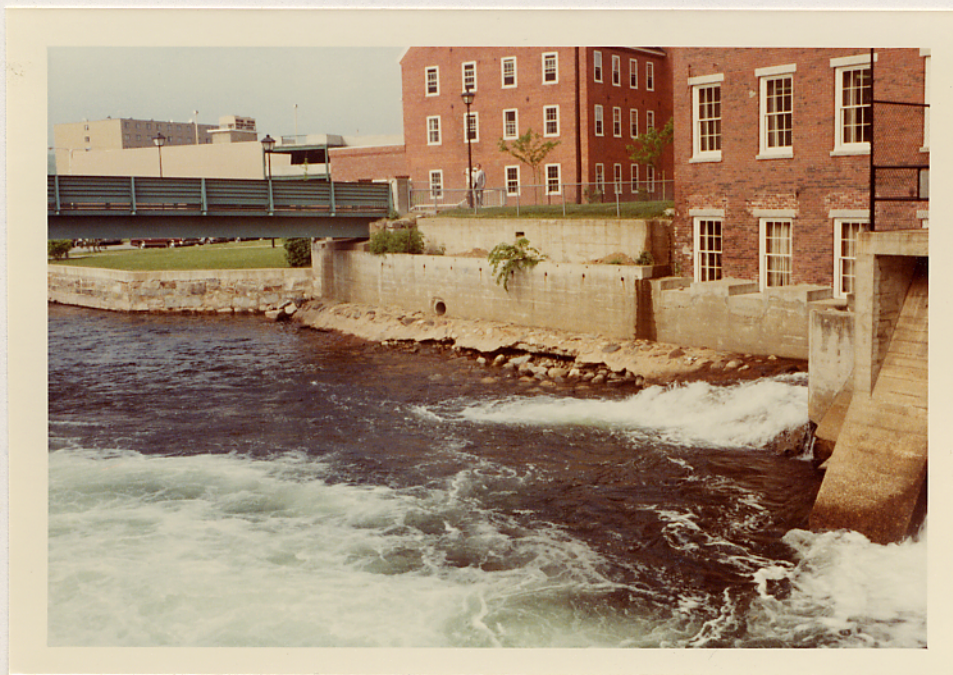
The concrete in both the front and back walls is in good condition. However, the slope revetment placed as toe protection adjacent to the front wall has been seriously eroded. Probing reveals that voids up to 6 feet in depth occur under the foundation of the front wall; approximately 6 feet of the front wall footing are exposed.

The erosion of the slope revetment along the right training wall presents no hazard to the dam, but requires attention to prevent potential undermining of the building foundations.

4. View from dam of erosion on right
side of downstream channel
